Mushroom Express

33777 Valley Center Rd
Valley Center, California

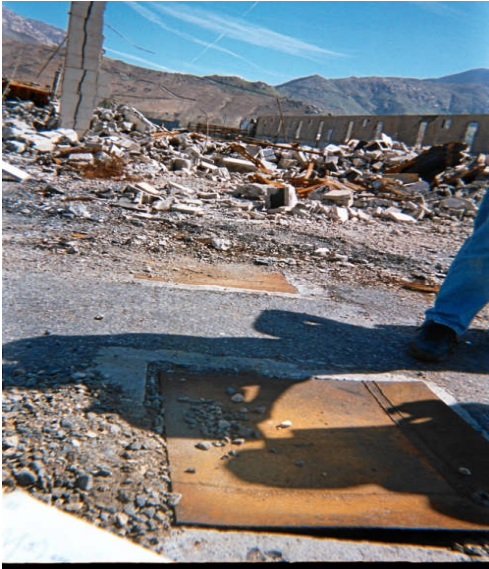
PHOTOGRAPH 1:

Sanitary wastewater from entire lot is plumbed to a septic system (*UIC 1a and 1b*). Former structures both had septic plumbing that extended from the west side of the building to Valley Center Road.

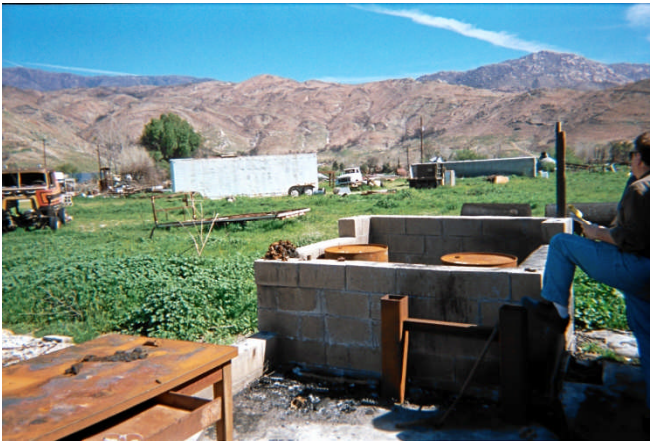
PHOTOGRAPH 2:

Waste oil pad contains two drums with minimal contents (waste oil). Does not present an immediate risk to health or the environment, but should be managed appropriately. Historical spills and usage warrants shallow subsurface investigation in the area.

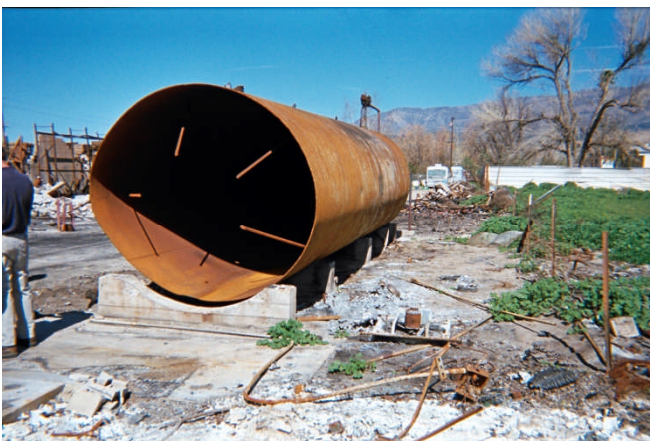
PHOTOGRAPH 3:

Diesel storage tank was burned during the fire and the south wall of the tank 'blew' off. It is likely diesel was spilled on the south side of the tank, this area should be investigated

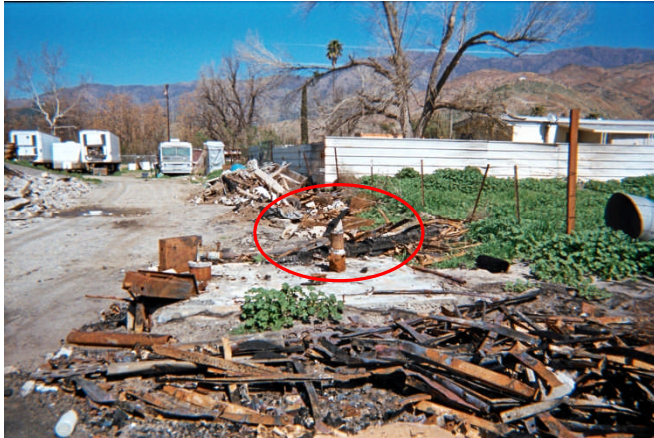
PHOTOGRAPH 4:

Drinking water well, Tribe is concerned that the well may act as a conduit for contaminants associated with the site into the underlying aquifer. The well should be sampled to determine if contamination is likely.

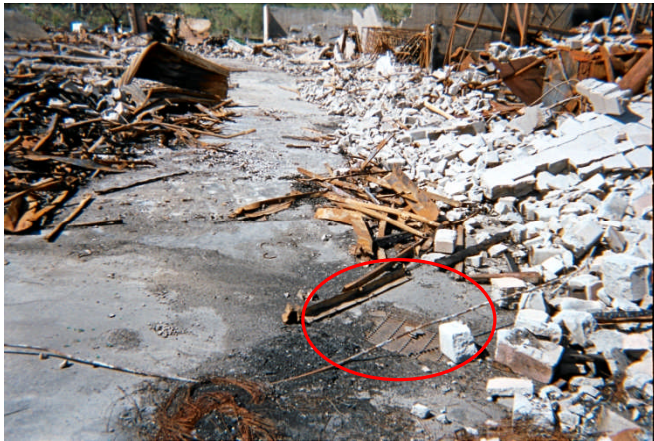
PHOTOGRAPH 5:

Cooling humidifier system (UIC 2) - drain

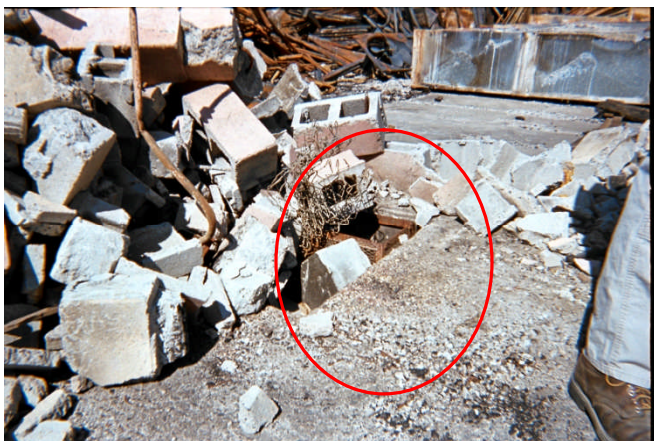
PHOTOGRAPH 6:

Cooling humidifier system (UIC 2) - sump

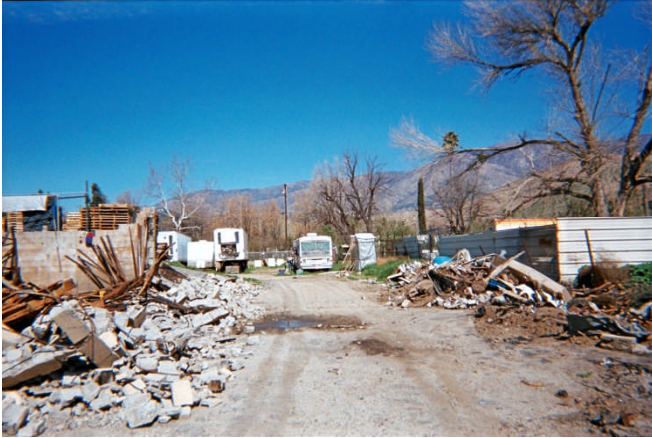
PHOTOGRAPH 7:

Cooling humidifier system (*UIC 2*) – watering area

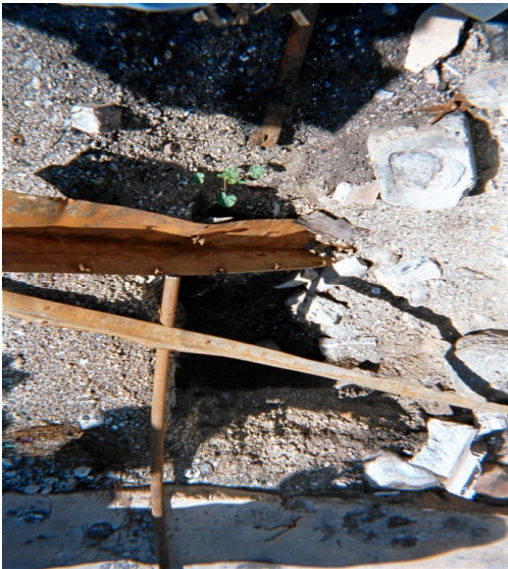
PHOTOGRAPH 8:

Laundry water sumps (*UIC 3 and 4*) are located on the south side of the former south structure. Although this area was reportedly used for laundry water (grey water) for 2 – 4 weeks, it should be investigated.
